13.0 Naturita, Colorado, Disposal Site

13.1 Compliance Summary

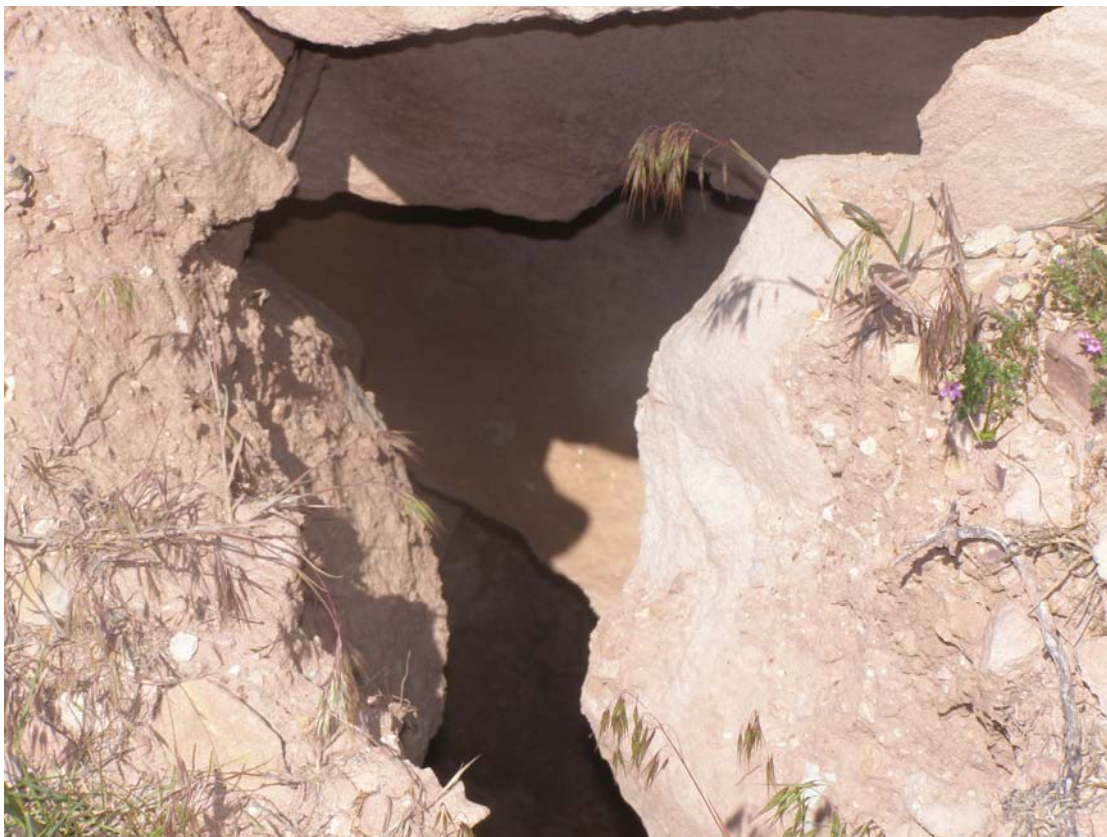
The Naturita, Colorado, Disposal Site was inspected on May 9, 2007, and was in excellent condition. Site maintenance activities performed in 2007 included spraying noxious weeds with herbicide (two separate applications). Minor perimeter fence repairs are needed. Minor erosion along the west side of the upper access road to the monitor wells requires maintenance. No cause for a follow-up or contingency inspection was identified.

NAD 5/2007. PL-1. Erosion along west side of the access road.

DOE applied herbicide to control noxious weeds during June and September 2007. Minor erosion along the west side of the access road requires maintenance. Loose and broken wire strands in the perimeter fence require repair.

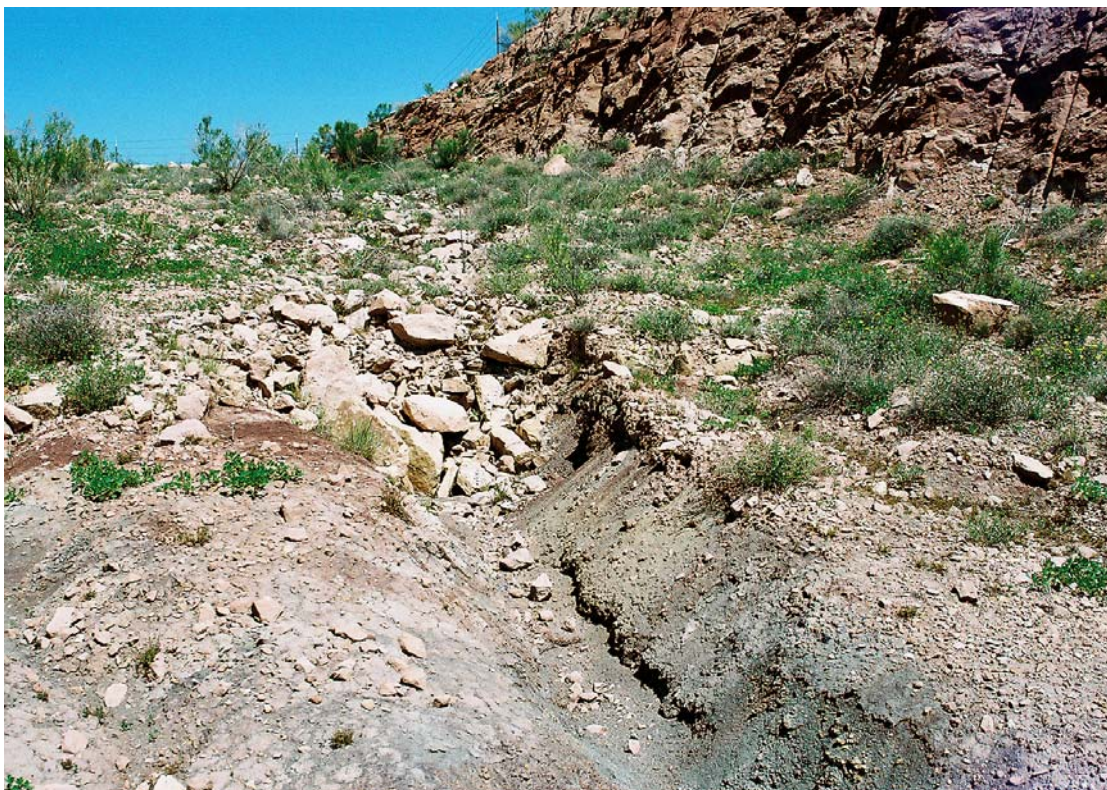
13A The toe drain on the west side of the cell exits through a channel quarried through the wall of the Burbank Pit and into Hieroglyphic Canyon and finally to the San Miguel River. Some sediment has accumulated in the upper end of the western toe drain, allowing scattered weeds and grasses to grow. Farther down this drain, beyond the armored portion, water is beginning to erode softer bedrock. A knickpoint has formed at the intersection of shale and overlying sandstone units within the Salt Wash Member of the Morrison Formation (PL–2). This erosion does not affect the performance of the toe drain but will continue to be monitored. Russian knapweed, a noxious weed, has been found in the past in the lower drainage area and on the island of land separating the drainage area from the adjacent Umetco UMTRCA Title II disposal cell. Although not observed during the May 2007 inspection, noxious weeds were identified during follow-up weed-control monitoring efforts and treated in June and September 2007 by a licensed herbicide applicator.

NAD 5/2007. PL-2. Headcut upgradient of the west drainage outlet.

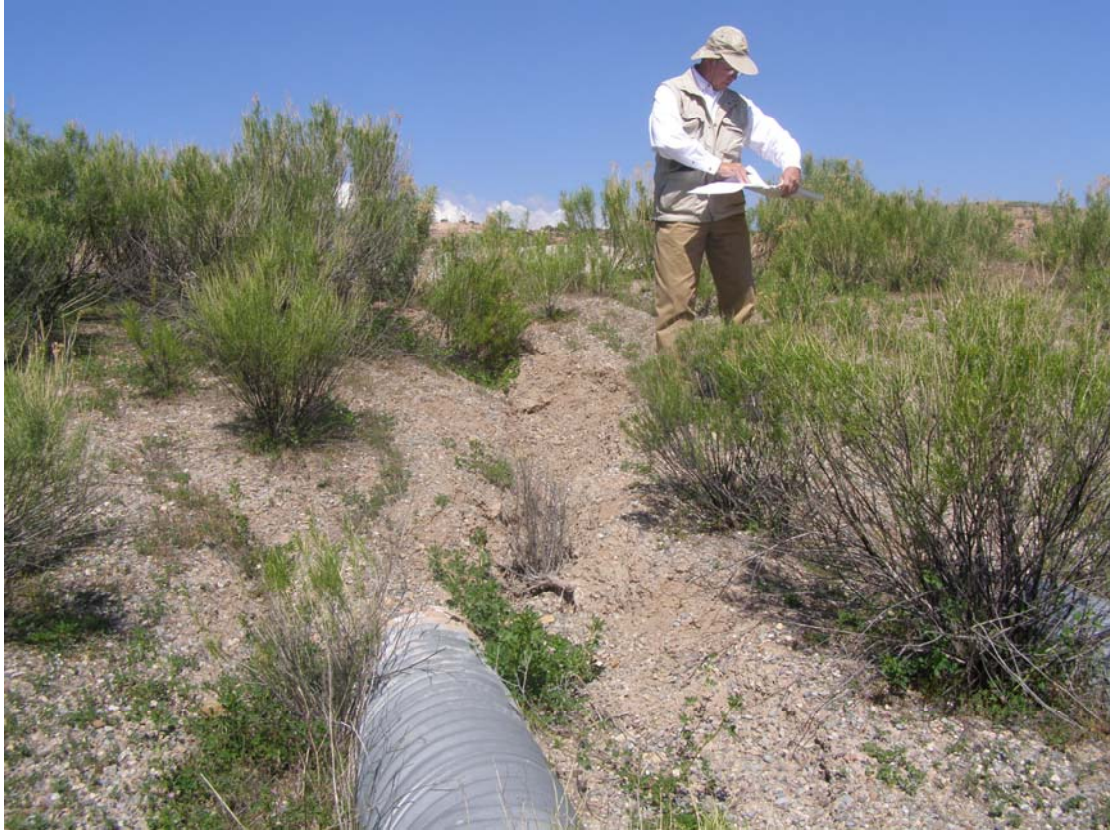
The east toe drain extends through the adjacent Umetco UMTRCA Title II disposal site and crosses beneath County Road EE22 through five culverts. Rills are present in the road embankment over the culvert outlets but are not affecting the road surface at this time (PL–3). Minor erosion of loose material has occurred in the drain outlet area, but the underlying sandstone bedrock limits further erosion. Water was observed in the drain at the time of the inspection.

NAD 5/2007. PL-3. Erosion at the east toe drain outlet, east side of County Road EE22.

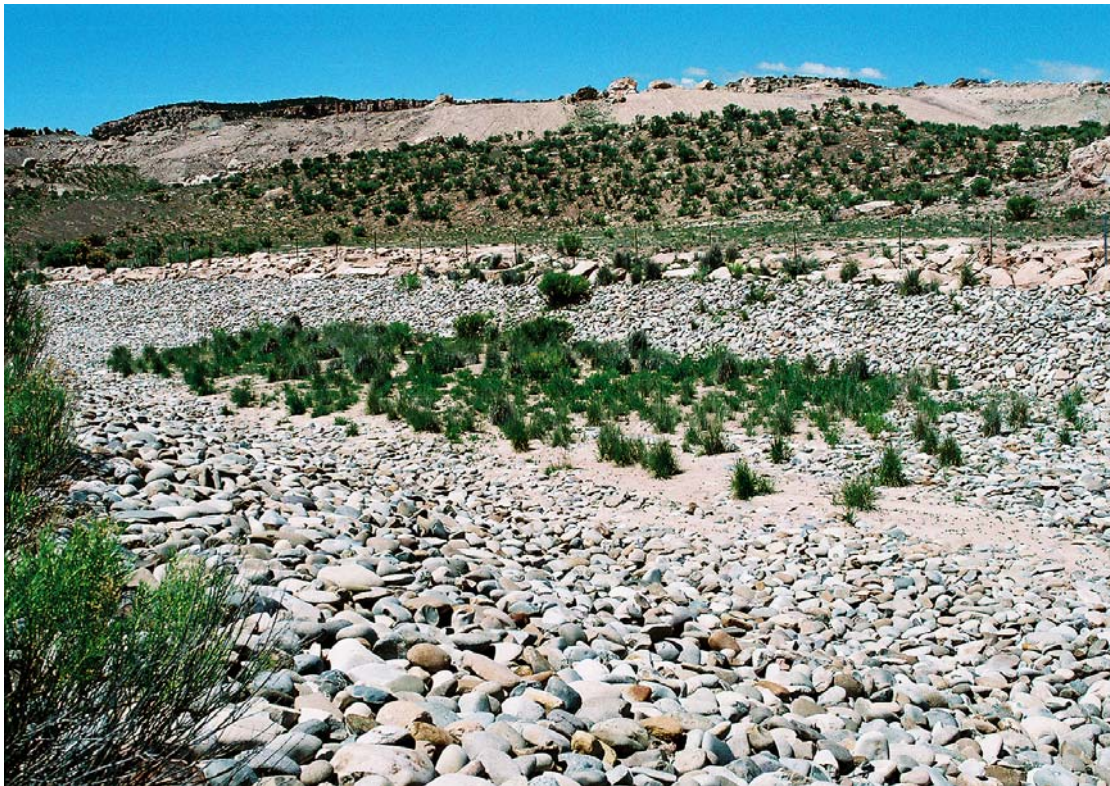
Interceptor Channel—A riprap-armored interceptor channel, upgradient and northwest of the disposal cell, diverts storm water and snowmelt run-on to the northeast across County Road EE22. Some erosion has occurred outside the property uphill from perimeter signs P23 and P21, resulting in deposition of sediment in the channel. The rills appear to be stable, and vegetation is establishing in the accumulated sediment in the channel (PL-4). Otherwise, the channel is in excellent condition and the sediment and vegetation do not impair the function of the channel. No culvert was installed where the channel crosses the road, so the road could potentially be damaged if and when storm water exits the channel. (To date, storm water has not affected the road.)

NAD 5/2007. PL-4. Sediment accumulation and vegetation growth in the interceptor channel.
